METALLURGICAL CHANGES IN THE HIGH TEMPERATURE  
FRETTING OF Ni and Ti ALLOYS

Second Technical Report

R.B. Waterhouse

October 1977

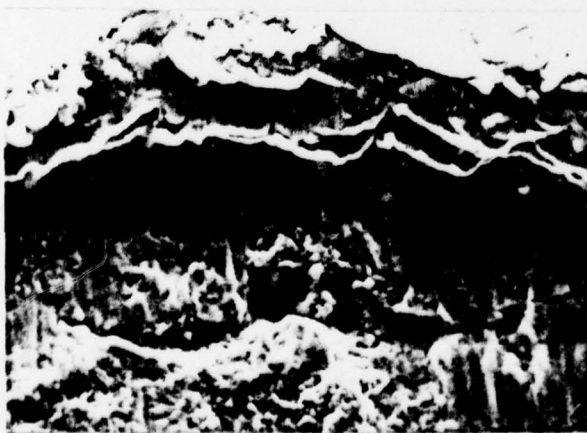
PLATE V

Plate V shows evidence of the transferred material being made up of multiple layers. As in the previous case the Al content of the transferred material was lower than that of the original surface.

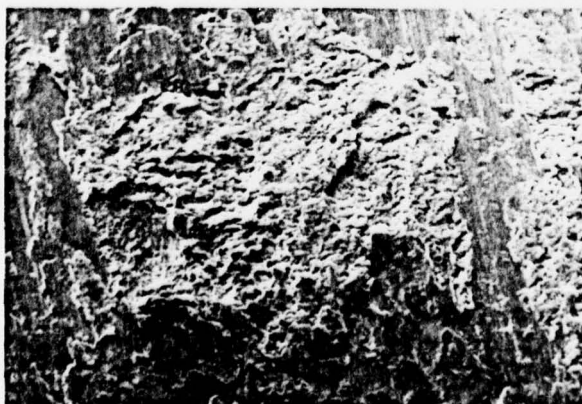
PLATE XI

Specimen S30  $\pm 77 \text{ MN/m}^2$  10,998,100 cycles

Plate XI shows a dumbbell shaped depression where delamination has occurred within a region of transferred material.

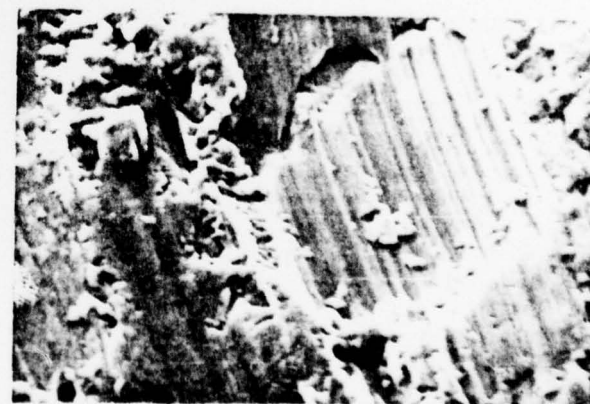
PLATE XII

Plate XII shows the break up by delamination of transferred material.

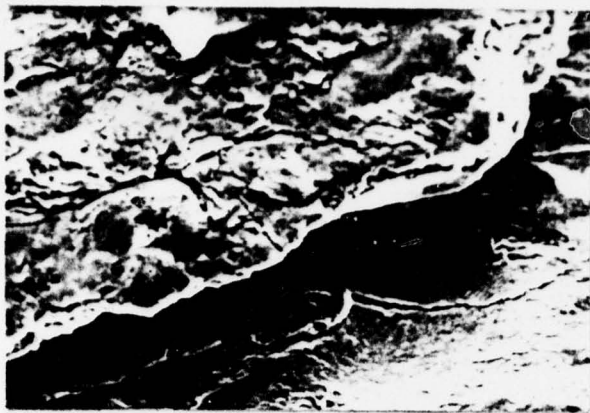
PLATE XIII

Specimen 97      20°C      ±260 MN/m<sup>2</sup>      131,000 cycles

Plate XIII shows a layered structure similar to that seen in the titanium alloy.

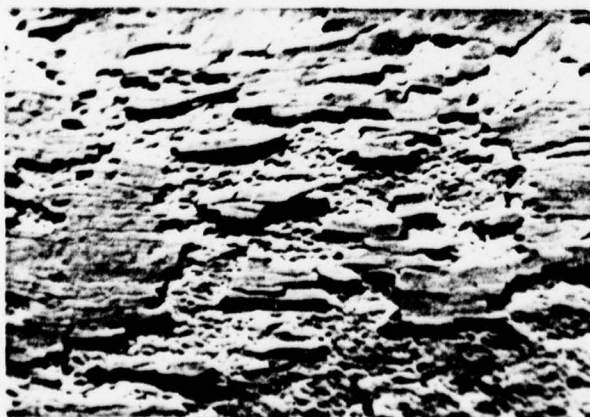
PLATE XVII

Plate XVII is an enlarged view of part of the same field in the previous plate showing removal of material by delamination apparently with the formation of numerous hair-line cracks. The chemical composition of the delaminating layer and the underlying material is identical.

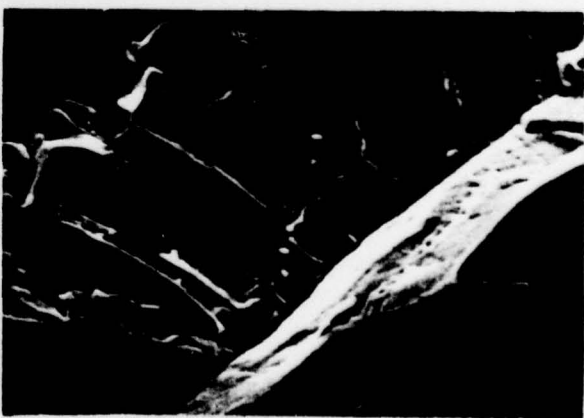
PLATE XXX

Plate XXX shows the development of facets in transferred material.
